This interim report is based on the fieldwork undertaken between 15th and 18th December 2016 and 7th and 8th May 2017 and data from the survey and record. It follows the discussion and decision by Cadw on the next steps to be taken to ensure conservation of the kiln and its interpretation. A full and final report will be integrated with the findings of the watching brief by Nick Tavener of the site works which started in January 2017.

## 1. Summary

The surviving 15th/16th-century kiln at Newport is preserved beneath the stage of the Memorial Hall in remarkably good condition as a result of a decision taken in 1920-1 by the hall trustees encouraged by Mortimer Wheeler, then Keeper of Archaeology at the National Museum of Wales. Investigation in December 2016 found that most of the substructure of the kiln is intact. The kiln is a simple updraft design with two opposed fireboxes and is a direct antecedent of the 19th-century example from the Ewenny Pottery re-erected at St Fagans National History Museum. Cadw kindly offered an award of a grant for the archaeological work on the monument as part of a Heritage Lottery Funded scheme to conserve and provide public access to the kiln.

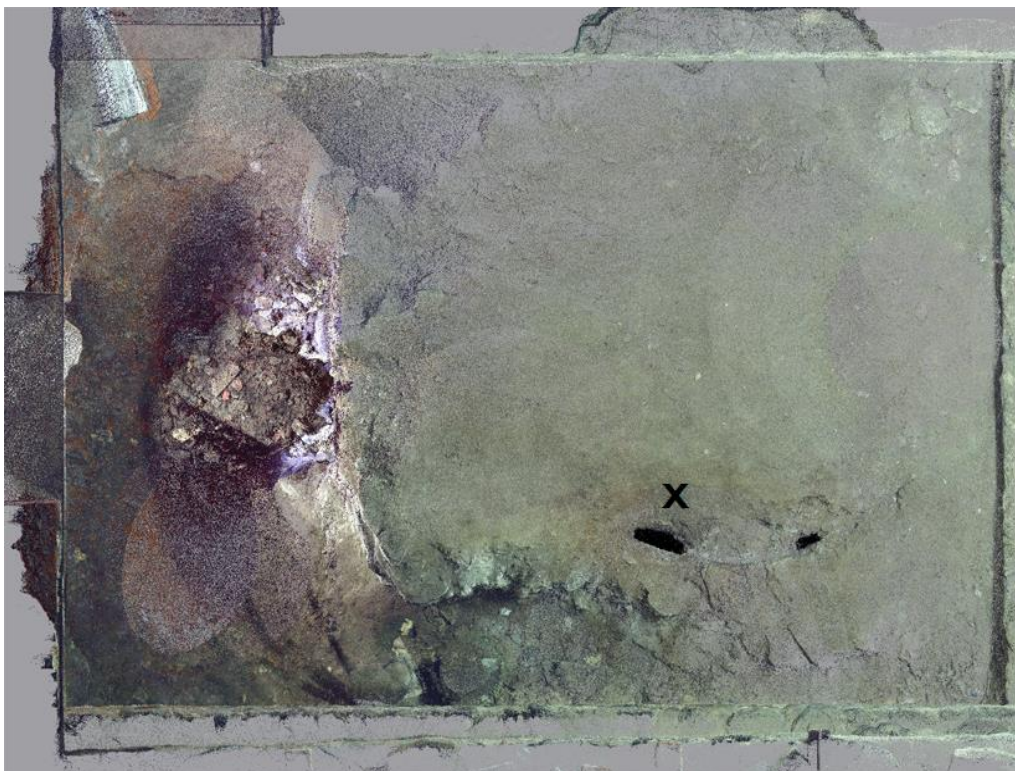
*Figure 1 Plan view of the kiln before investigation. The exposed firebox is at the lefthand (east) side. The wall dividing the substructure into two halves could be clearly seen on the right inside vent X (BS).*

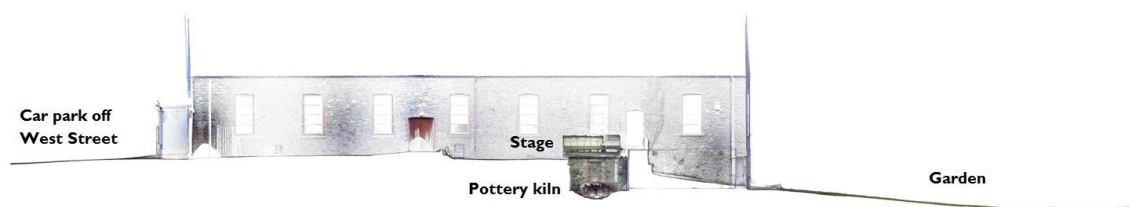
*Figure 2 Section through the site from south to north showing the position of the kiln in relation to the hall and its stage (BS).*

3.2 The laser scan survey illustrates the way in which the buildings, including the kiln, have been terraced into the slope falling away northwards from the street frontage (figure 2).

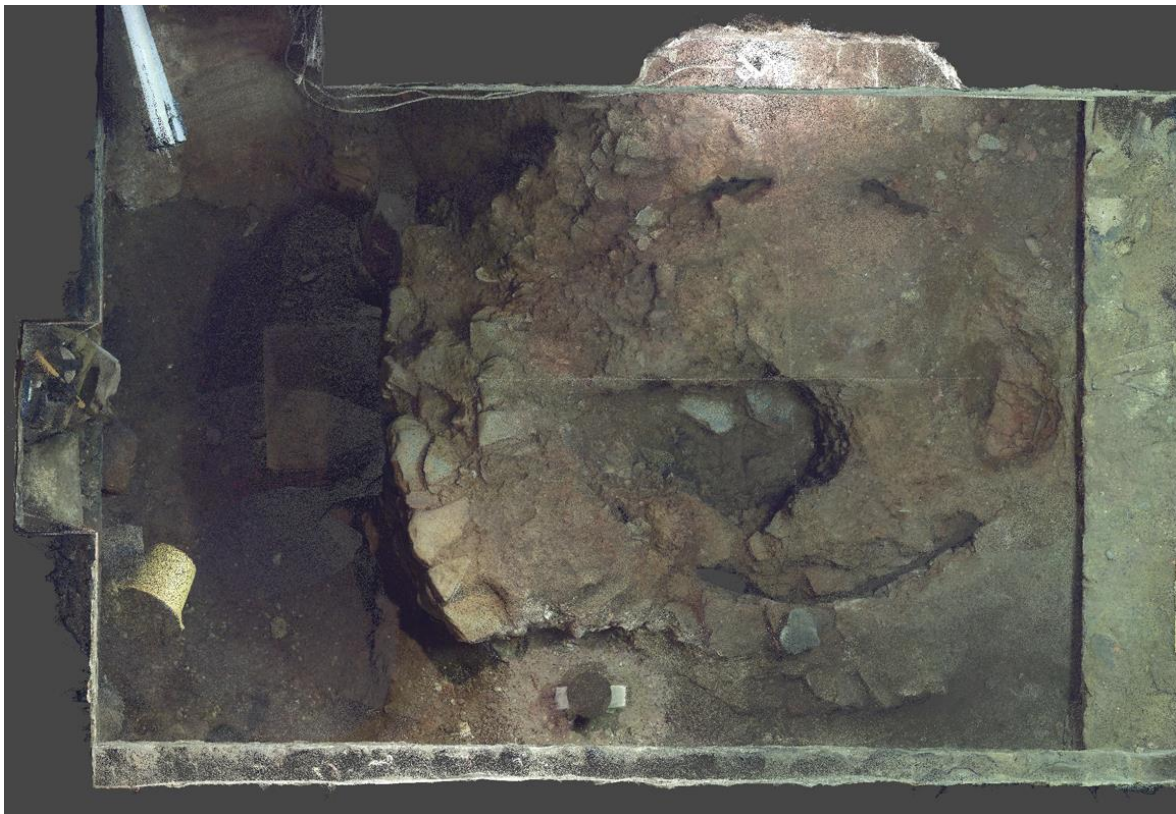
Figure 3 Plan view showing the 'excavation' of the 1920s (BS).

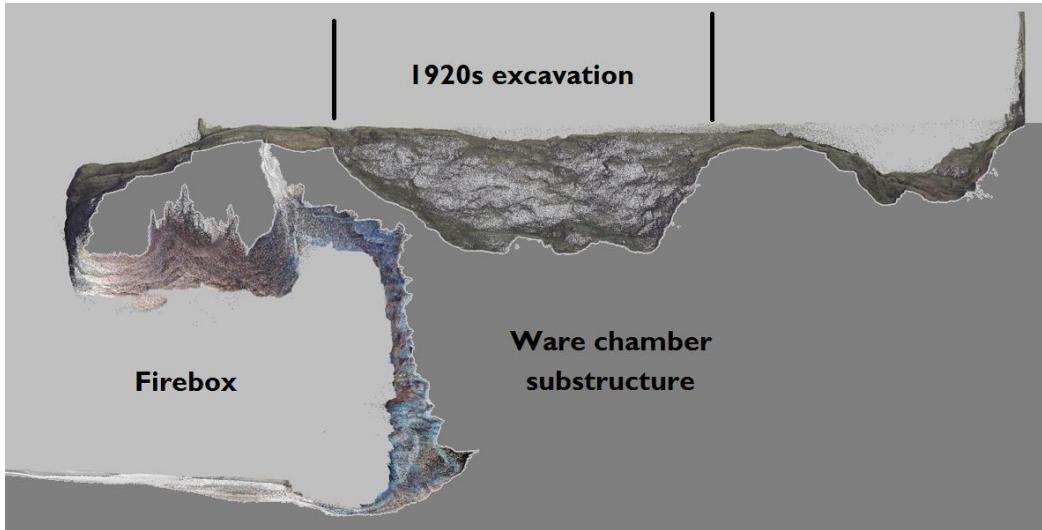
Figure 4 Section through the kiln showing the 'excavation' of the 1920s (BS).

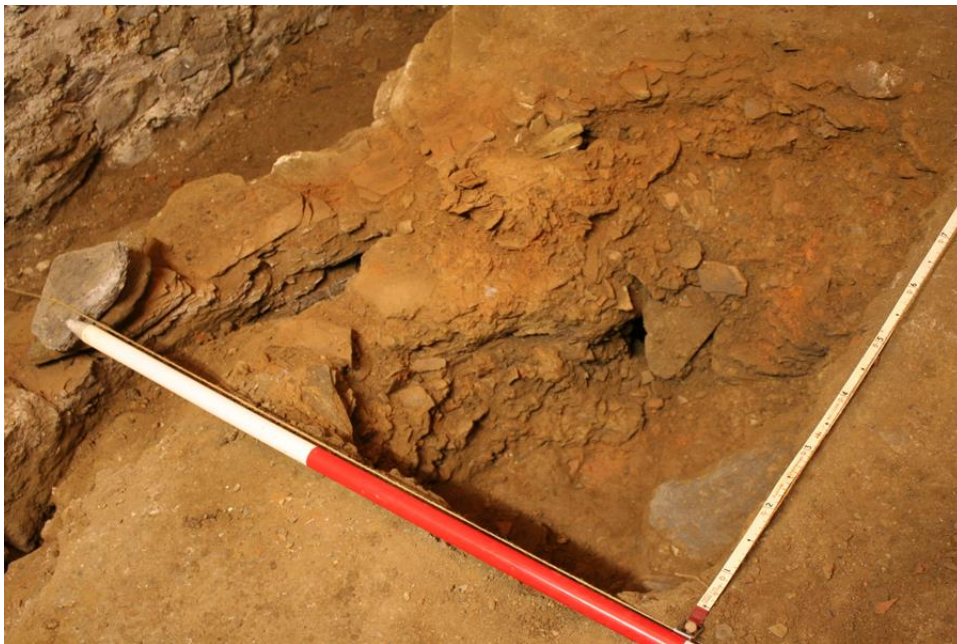
Figure 5 The earlier excavation and damage it caused to the roof of the flue.

5.4 The fill of the ware chamber was tested by stratigraphically excavating the southwest quadrant of 1920s and later fill. Similar excavation of two other quadrants confirmed that an excavation had been dug in the 1920s or possibly later roughly occupying the southwest quadrant. Its fill contained sherds of transfer-printed creamware, a sherd of porcelain, an unmarked clay pipe stem, the heel of a shoe and other material of a similar date as well as sherds of 15th/16th-century earthenware (figures 3 and 4). This intervention had damaged the structures over the internal flue, dislodging one of the fired-clay bars that support the roof (figures 5 and 12).

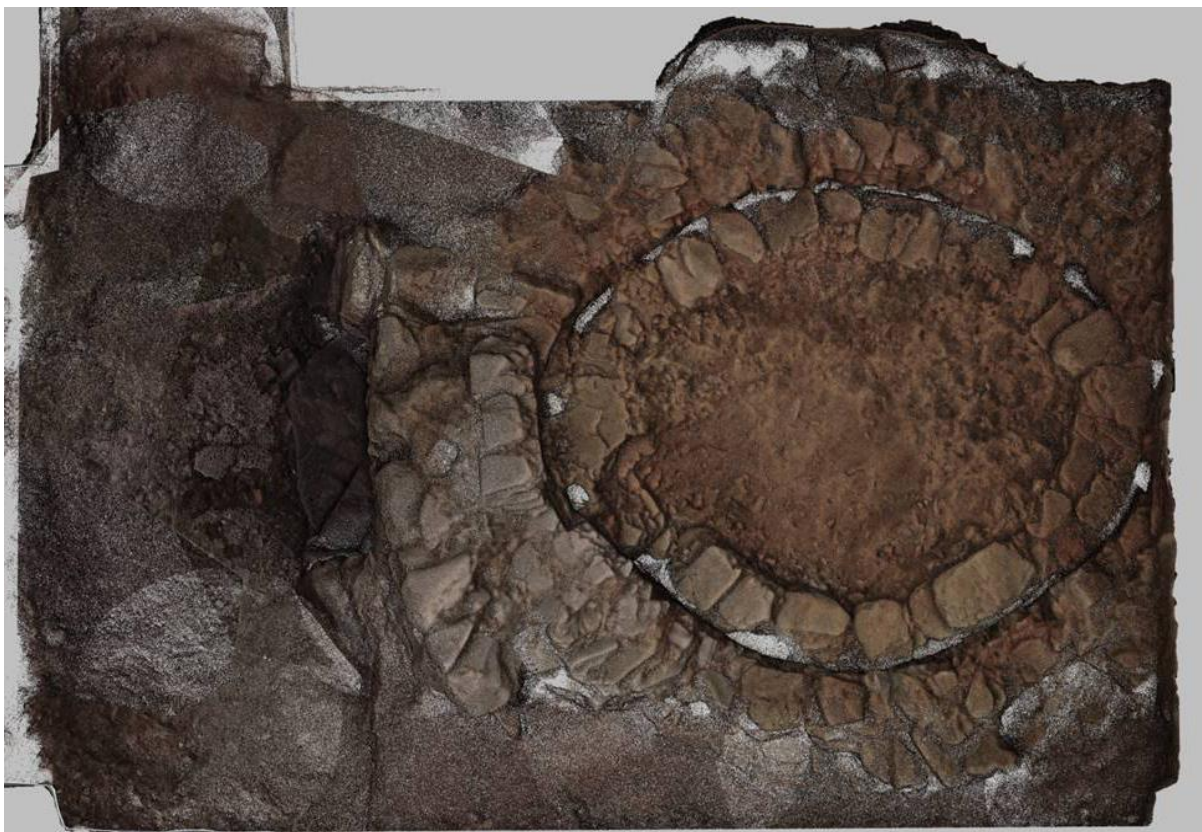
*Figure 6 Plan view of the kiln at the end of the investigation with debris removed (generated from the point cloud by Bill Stebbing). The vents are highlighted by being left in greyscale.*

5.6 A final series of scans record the monument as left at the end of the investigation (figure 6). The otherwise inaccessible parts of the substructure were recorded using the expedient of a mobile telephone on the end of a selfie stick.

6.2 The monument consists of the base of an oval updraft kiln that measured 2.25m by 1.80m within the ware chamber (figures 6 and 7).

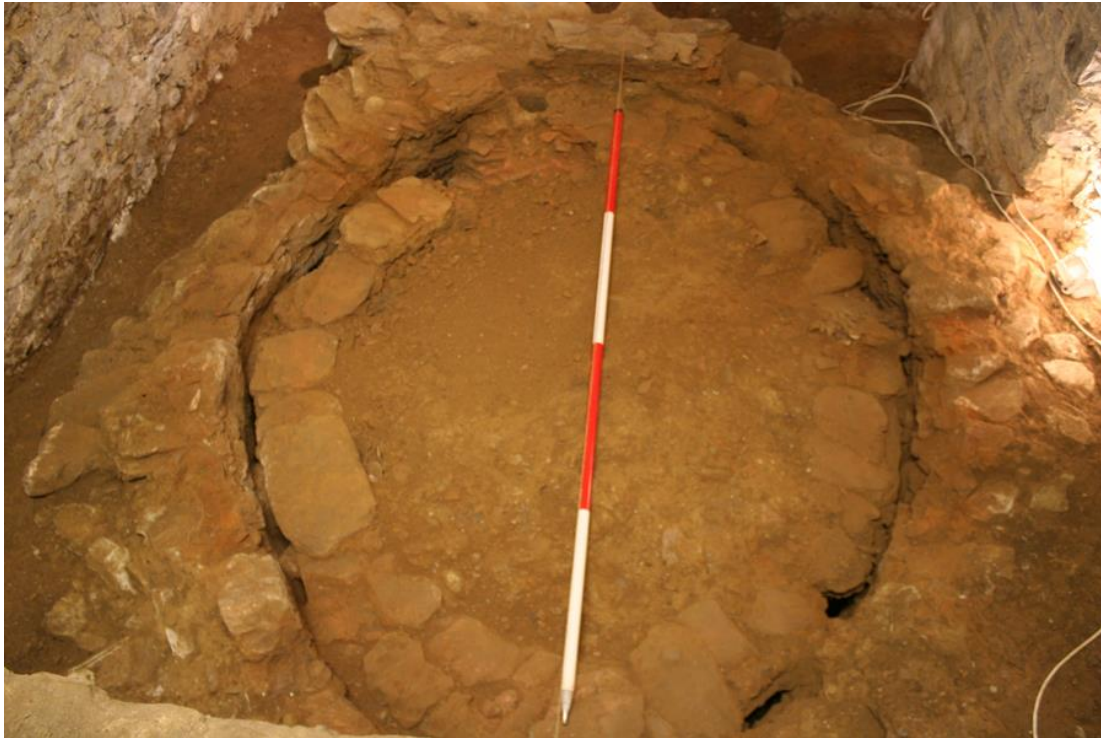
*Figure 7 Interior of the kiln looking west towards the surviving exposed firebox. Note the channel above the vents from the underfloor flues and the surviving modelled clay flue to the left of the far end of the ranging rod. The three stones that may form the threshold are just beyond the far end of the ranging rod.*

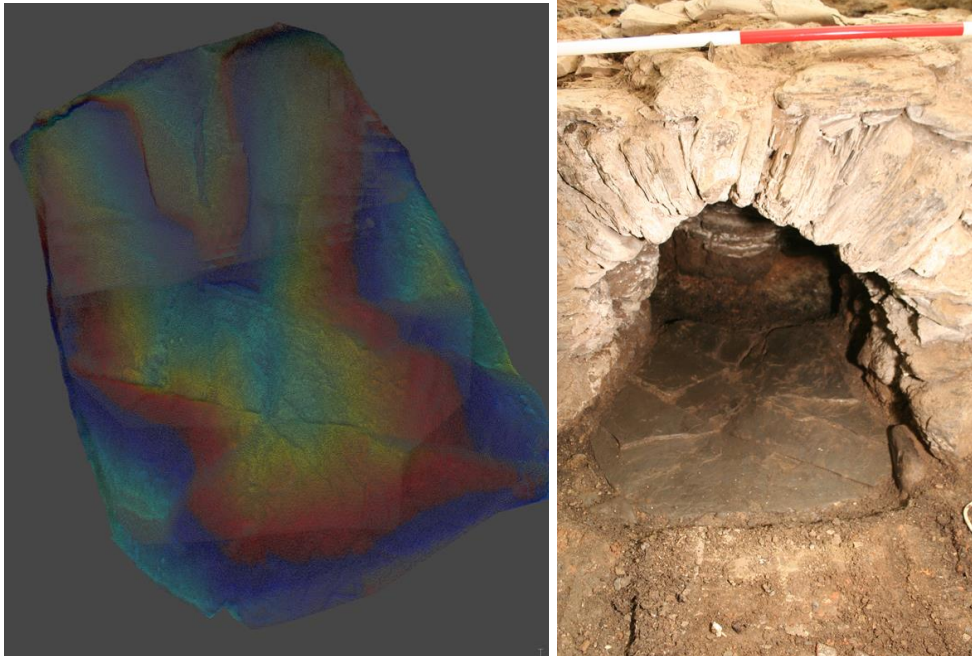
*Figures 8 & 9 Colourised contour record of the surface of the slate slab forming the floor of the western firebox: the outer edge is at the bottom, the inner at the top (BS). The contours are at 15mm intervals. The photograph alongside shows the slab as seen from the mouth of the firebox.*

The western firebox measures 0.76m wide by 1.10m long by 0.72m tall at the front rising to 0.76m at the rear. It is built with an arched head in two distinct parts. The inner is constructed of relatively thin slates; the outer 0.37m of thicker blocks, possibly reflecting that the extension was added to the core substructure as it was built. The junction can be seen clearly in figures 4 and 8. It can also be seen that the firebox tapers slightly in plan to 0.64m whilst widening in its height as it meets the internal flue. The floor of the firebox consists of a single slab of slate 0.82m to 0.59m wide and 0.98m long. As can be seen in section (figure 4) and in the colourised contour record, the upper surface has worn towards the rear into a noticeable groove (figure 8).

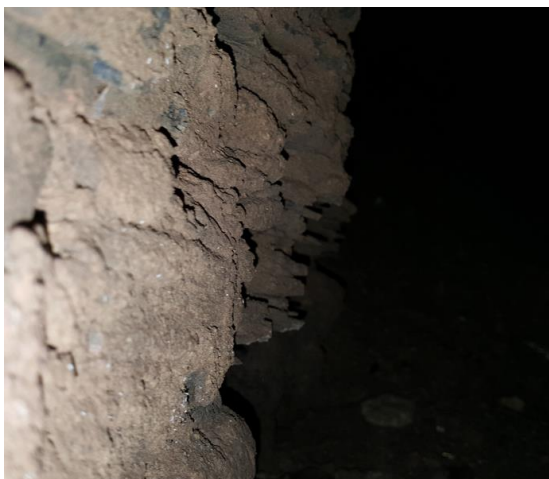
*Figure 10 The jamb of the second firebox.*

The existence of the easternmost firebox had been postulated by Slade in 2013 on the basis of the distinct division of the substructure into two halves. It was confirmed when photographs taken by mobile telephone through the newly cleared vents showed the jambs and arch of this second firebox open and undisturbed surviving under the 1920s cross-wall (figure 10). Following contemporary models it can be expected that this firebox will be the mirror image of the first.

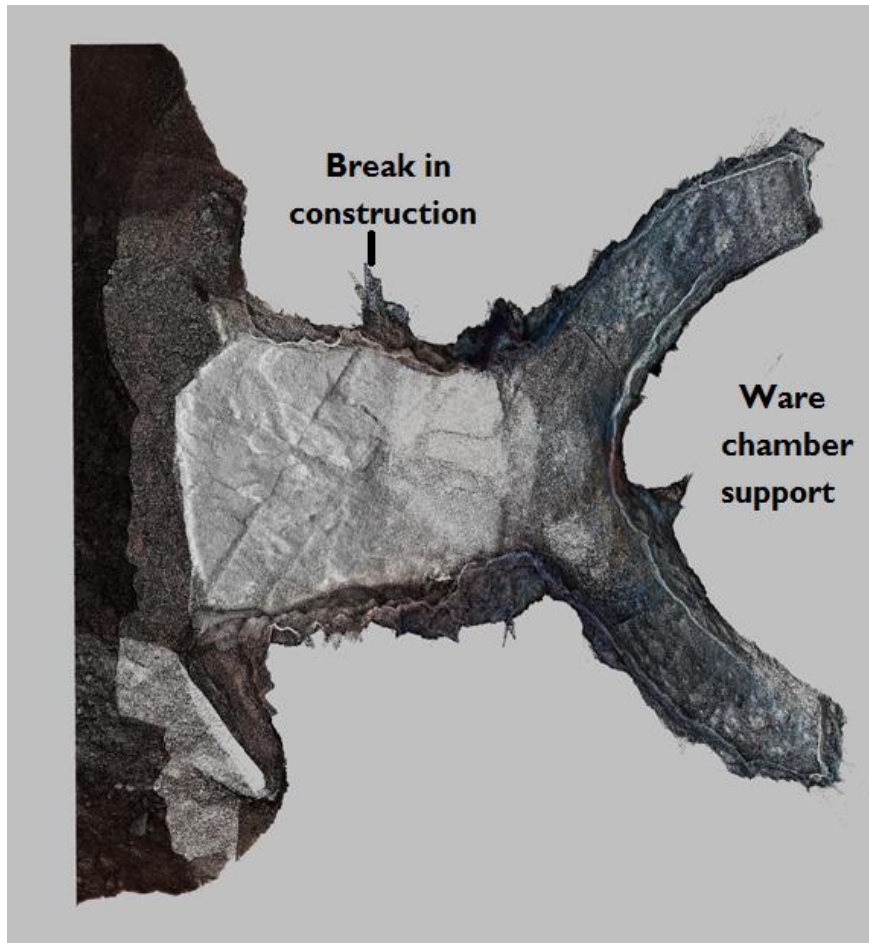
Figure 11 Plan of western firebox floor and western system of flues (BS).

The way in which the central drum presents a rounded angular end to the mouth of the firebox can be seen in figures 11 and 12. The same two figures show the squared ends of the two flues where they meet the cross wall that separates them from the eastern flue system.

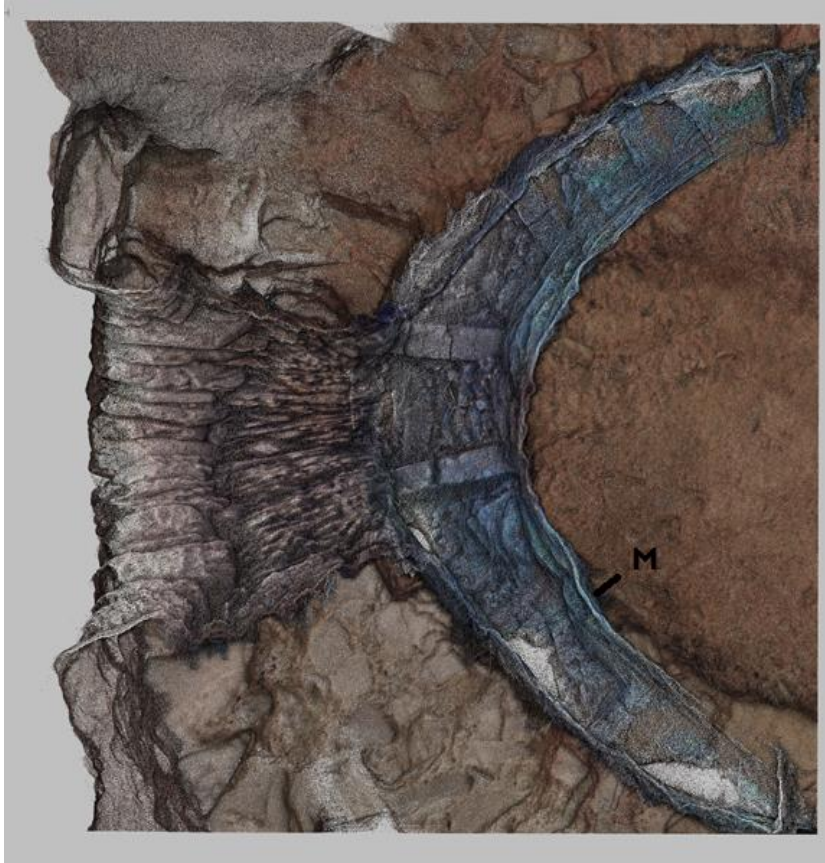
Figure 12 Plan view of the roof structure of the firebox and flues of the western half of the kiln. M indicates the position of the fired clay bar which was dislodged in the 1920s excavation (BS).

The drum is made of a roughly coursed slate skin in-filled with compacted earth and fragments of slate. This skin is corbelled out at the top on either side of fired clay bars, approximately 70mm square in section, bridging the gap between the drum and the inner wall of the kiln approximately 820 to 850mm above the floor of the flue (figures 12 and 13). Although these bars look highly fractured it should be noted that because they are embedded in the stonework at either end that they are perfectly secure. Only one bar is lost probably because the support it had at one end had been removed in the earlier excavation.

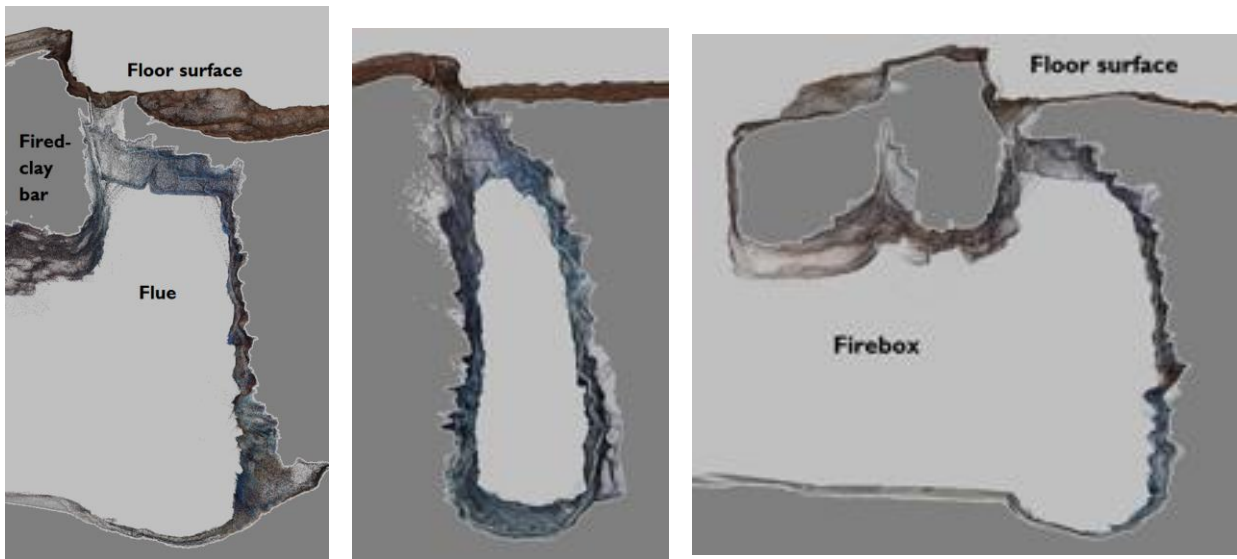
Figures 13, 14 and 15 Sections through the flue: 13 is on line A-A through a clay formed vent; 14 is more typical on line B-B and 15 on the line C-C; see figure 16 overleaf (not to scale) (BS).

The flues on either side of the drum vary from 270 to 285mm wide at the base and rise to about 790mm towards the top. The existence of the cross walls dividing the kiln base into two discreet halves was confirmed. No evidence was found of the existence of flues running across the ware chamber.

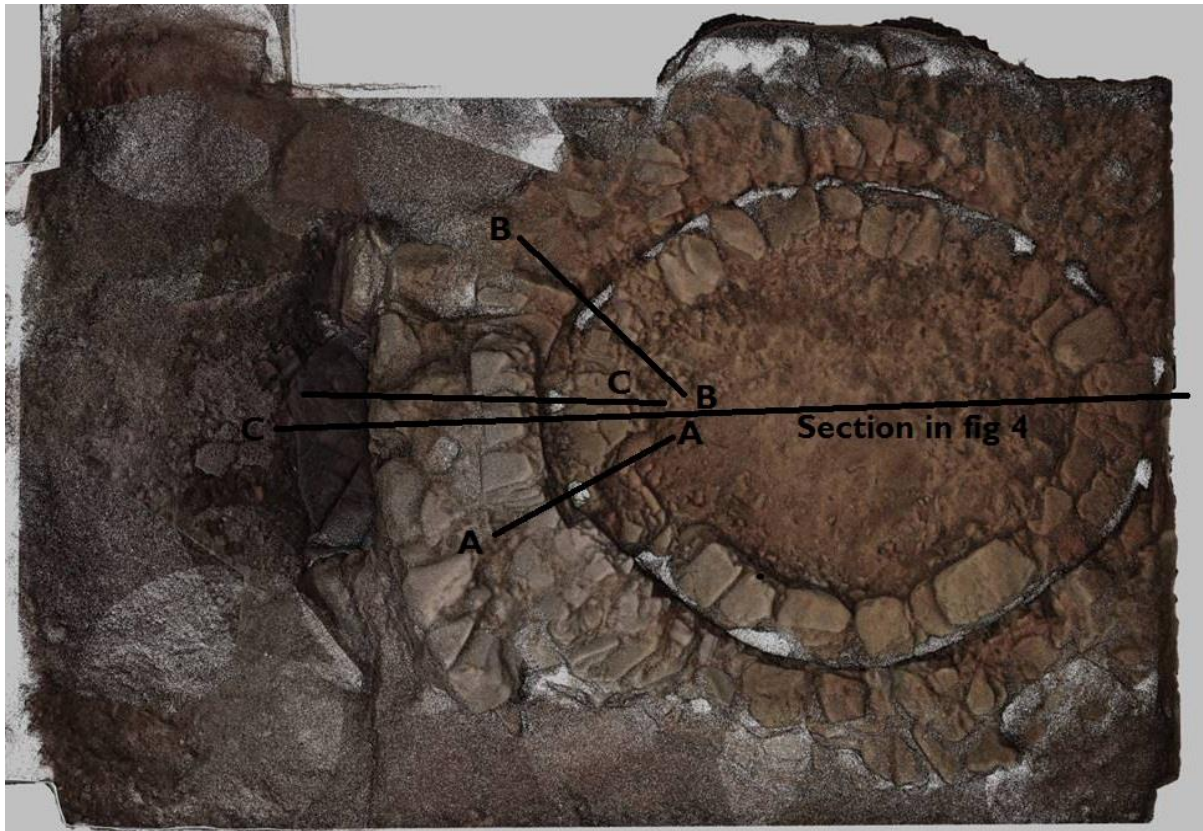
Figure 16 Positions of sections (BS).

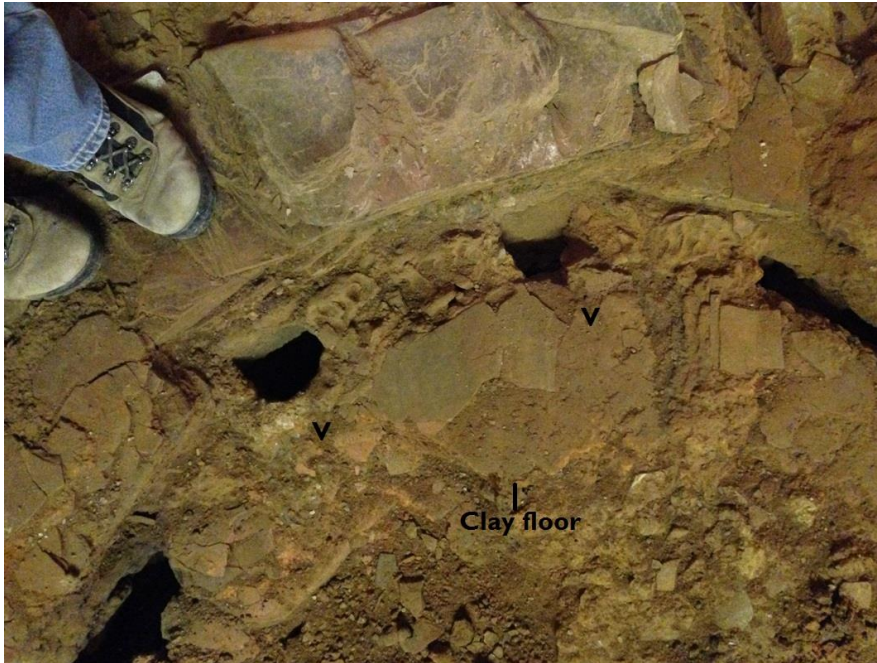
*Figure 17 The western end of the ware chamber floor showing two surviving clay-built vents (V) and a small area of rammed clay flooring surrounding and extending outwards from the slate edge to the floor. The damage to the left was caused by the test pit dug in 1921. The worn slabs above may have formed the threshold of a door to the ware chamber (see 6.7).*

At least two clay-formed vents survive in position in front of the western firebox (Figure 17 - V). The three clay built sides are impressed with the finger marks of the maker. The opening to the southwest measures 93mm along the inner wall of the ware chamber by a maximum of 51mm wide and is a maximum of 92mm deep. That to the northwest measures 113mm by 81mm. The top of the floor was approximately 900mm above the floor of the flues below. The slate edge within the area of the two vents is bonded with rammed clay that extends out into the floor for a short distance of 231mm). Other small areas of this surface are present further to the north. It is likely that the slates here represent the upper surface of the edge of the floor that was otherwise made of rammed clay. The surface is however entirely clean of glaze or other evidence of contact marks from pottery.

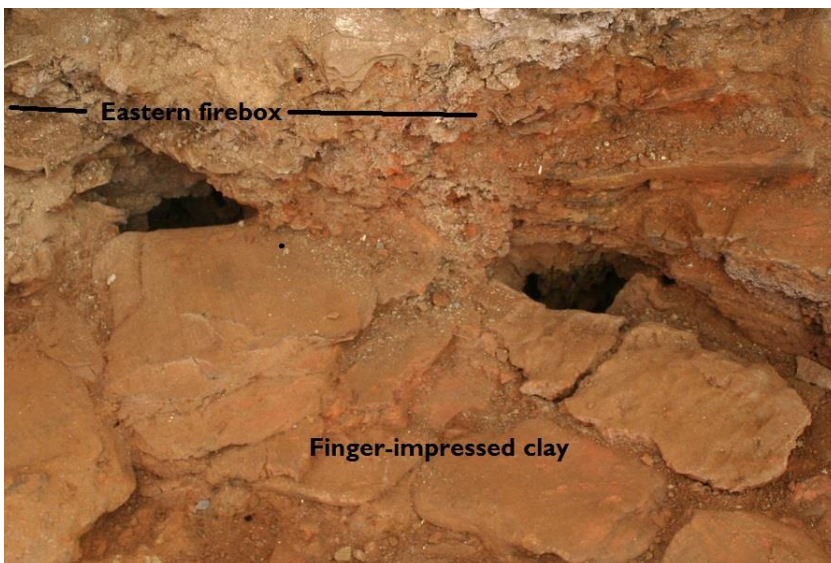
*Figure 18 The eastern end of the ware chamber floor showing patches of clay moulding another vent.*

There are further patches of clay impressed with finger marks at the eastern end of the ware chamber floor in a similar position in relation to the eastern firebox (Figure 18). To the south of the centre line a square slate-built vent matches those at the other end and may indicate the former presence of clay-built vents here too. This might suggest a symmetrical structure with small clay-built vents above the fireboxes and rectangular slate slots along the sides.

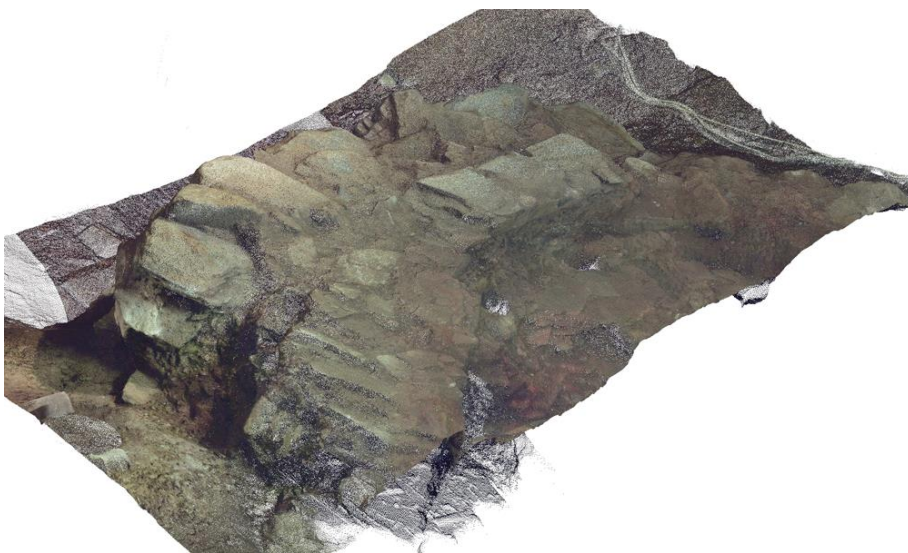
Figure 19 View of the threshold from the south east (BS).

Above the western firebox and centrally placed are three large pieces of slate with rounded well-worn upper surfaces. They are fractured at the extremities on both sides but fully extend to form a level platform. On the east side the inner edge is marked by a distinct recess in the wall of the ware chamber which is at its highest point here. The inner face is sharply cut – these pieces are building stone rather than rubble. Given the size of the kiln, whether it was open-topped or roofed, a door of some kind would be likely. These are often placed above fireboxes. It would seem plausible that this represents the threshold of a door into the ware chamber. The slight flattening of the elliptical shape of the kiln at this end reflects this and distinguishes it from the eastern end which although partially hidden under the cross wall is nonetheless a continuous curve. It creates an apparent thinning in the ware chamber wall but the precise form of the walls at this point is difficult to determine in part because of the truncation of both sides by the foundation trenches for the hall and in part by post-excavation wear again on both sides.

The surviving upper surface of the 'threshold' measures 453>531mm wide and 233>238mm deep. The full width is approximately 700mm.

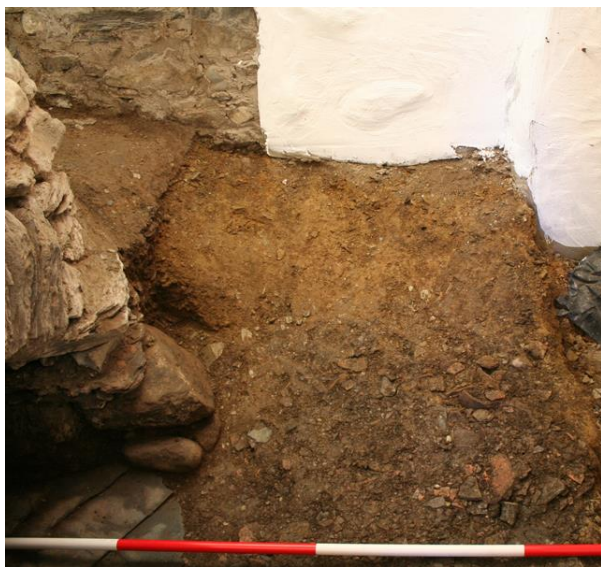
*Figure 20 Natural subsoil exposed by excavation cut by the 1920s foundation trench for the hall on the right and for the original construction of the kiln on the left by the firebox.*

Excavation of the area of the apron in front of the firebox showed that the kiln was built into the natural subsoil. Part of the foundation trench was clearly visible on the south-west corner (Figure 20). Later trample was left in place in front of the firebox to protect this surface.

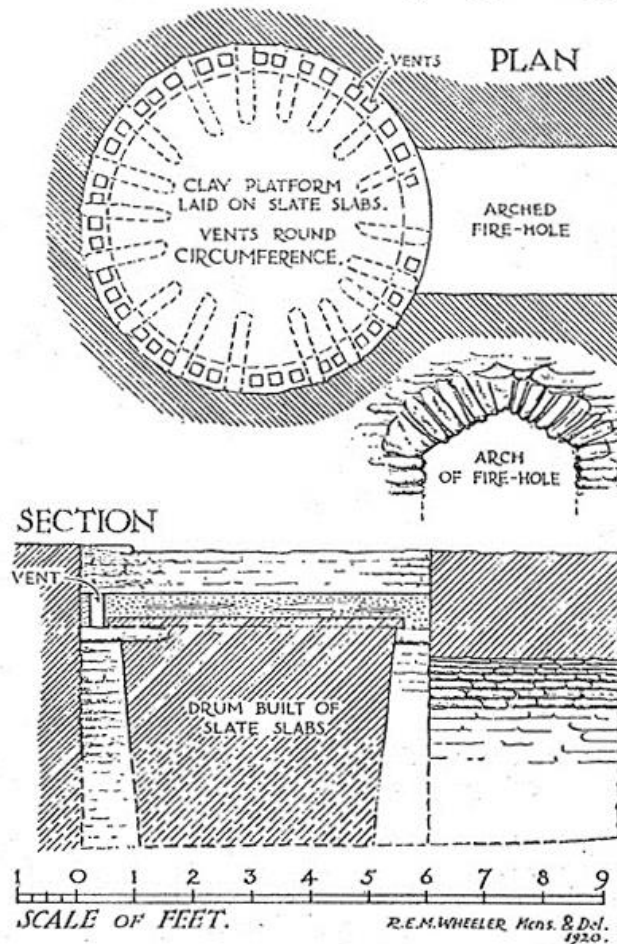
FIG. 50

Figure 21 The drawing reproduced in Talbot 1968, 126.

8.1 The kiln as recorded in December 2016 differs in a number of respects from the record of the 1921 excavations (Figure 21: Talbot 1968, 126). The shape is oval not circular. The substructure is divided into two to reflect two fireboxes. Each half had six clay-bar supports not a total of 18. The detail of the surviving clay-built vents is very much like the structures shown in Mortimer Wheeler's drawings but can only be shown to occur in certain limited areas of the circumference. The presence of undisturbed late medieval deposits over three-quarters of the kiln area demonstrates that this kiln was not fully excavated in 1921 and the shape of the kiln, the number and position of support bars and vents and the presence of a second firebox could not then have been determined.

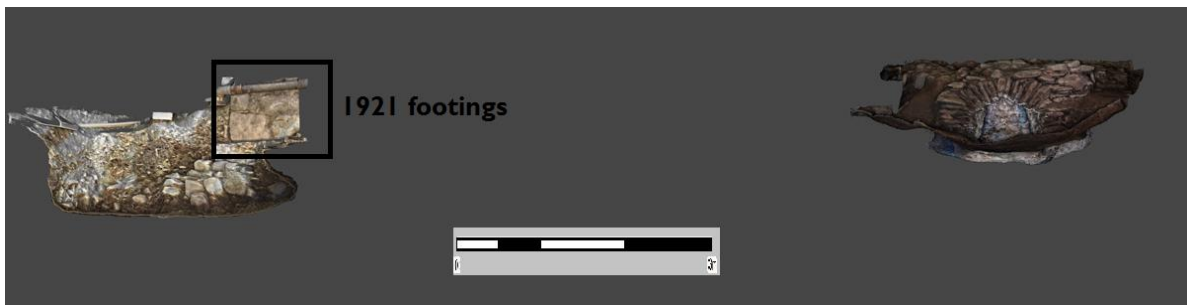
Figure 22 The relative position of the feature and kiln 2, a difference of 750mm between the bottom of the feature (left) and the floor of the firebox of kiln 2 (right) (BS).

9.1 A pit was discovered during site watching by Nick Tavener and speculation was aroused as to whether the structure could be evidence of kiln 1 (Tavener April 2017). The find will be reported in the full site report. Given speculation that it might be evidence of kiln 1, the feature was surveyed to ascertain its relationship with kiln 2 (Figures 22 & 23).

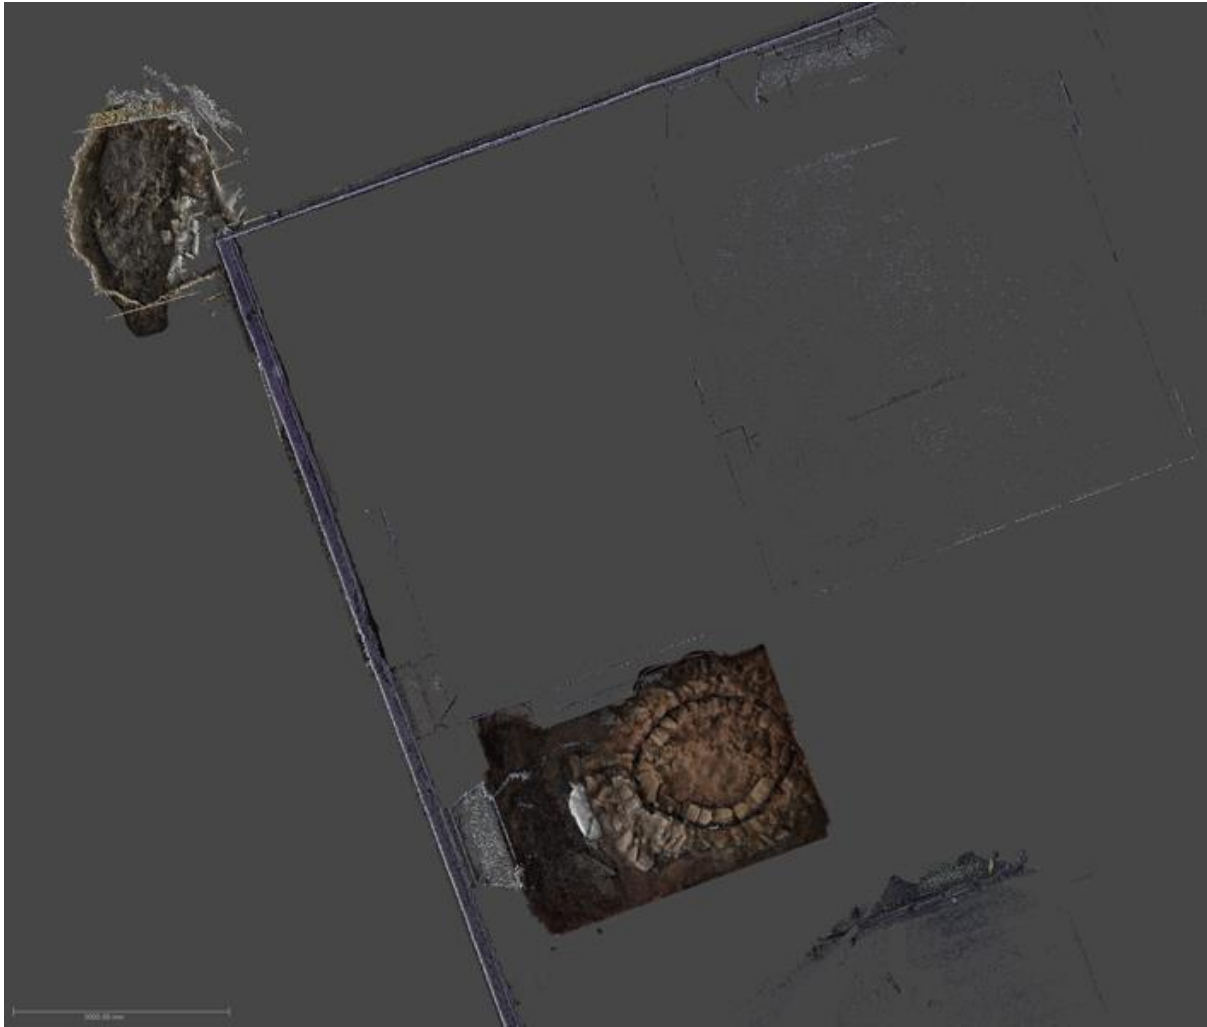
Figure 23 The relative position of the feature, the north-west corner of the hall and kiln 2 (BS).
